ENVIRONMENTAL EXPOSURE OF
SAMPLE MODEL MARINE FUEL TANKS

UL ASSIGNMENT 65WW63
File MM-36

UL ASSIGNMENT 65WW32
File MM-10

DATE: 27 February 1970

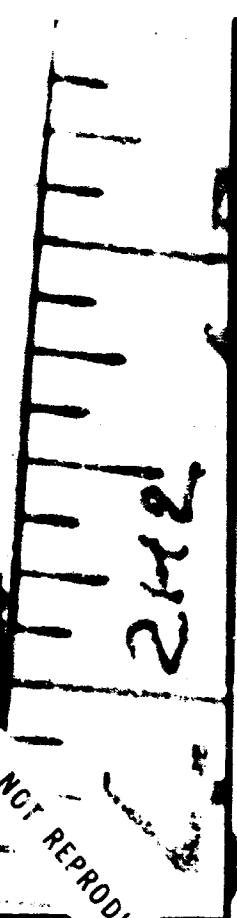
Crevice corrosion pitting and perforations in way of sea water reservoir. Index No. 1, 2, 3 and 8 are perforated. No. 2 shows severe corrosion pitted to .029".

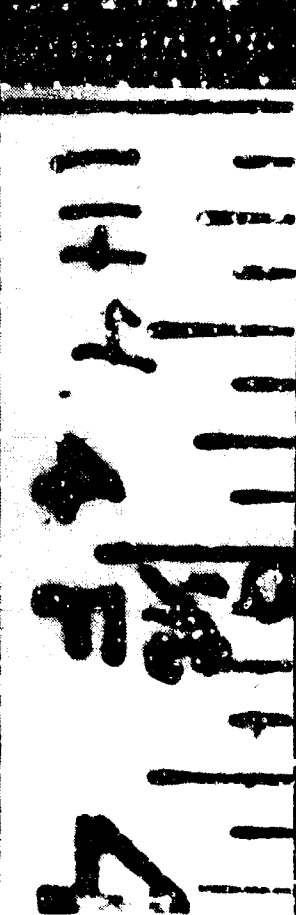
Final Inspection Report
FIG. NO. 33

Close-up view of corrosion found in way of sea water reservoir
faying surfaces. Note perforations in the typical crevices
formed.. See Fig. No. 31 for location.

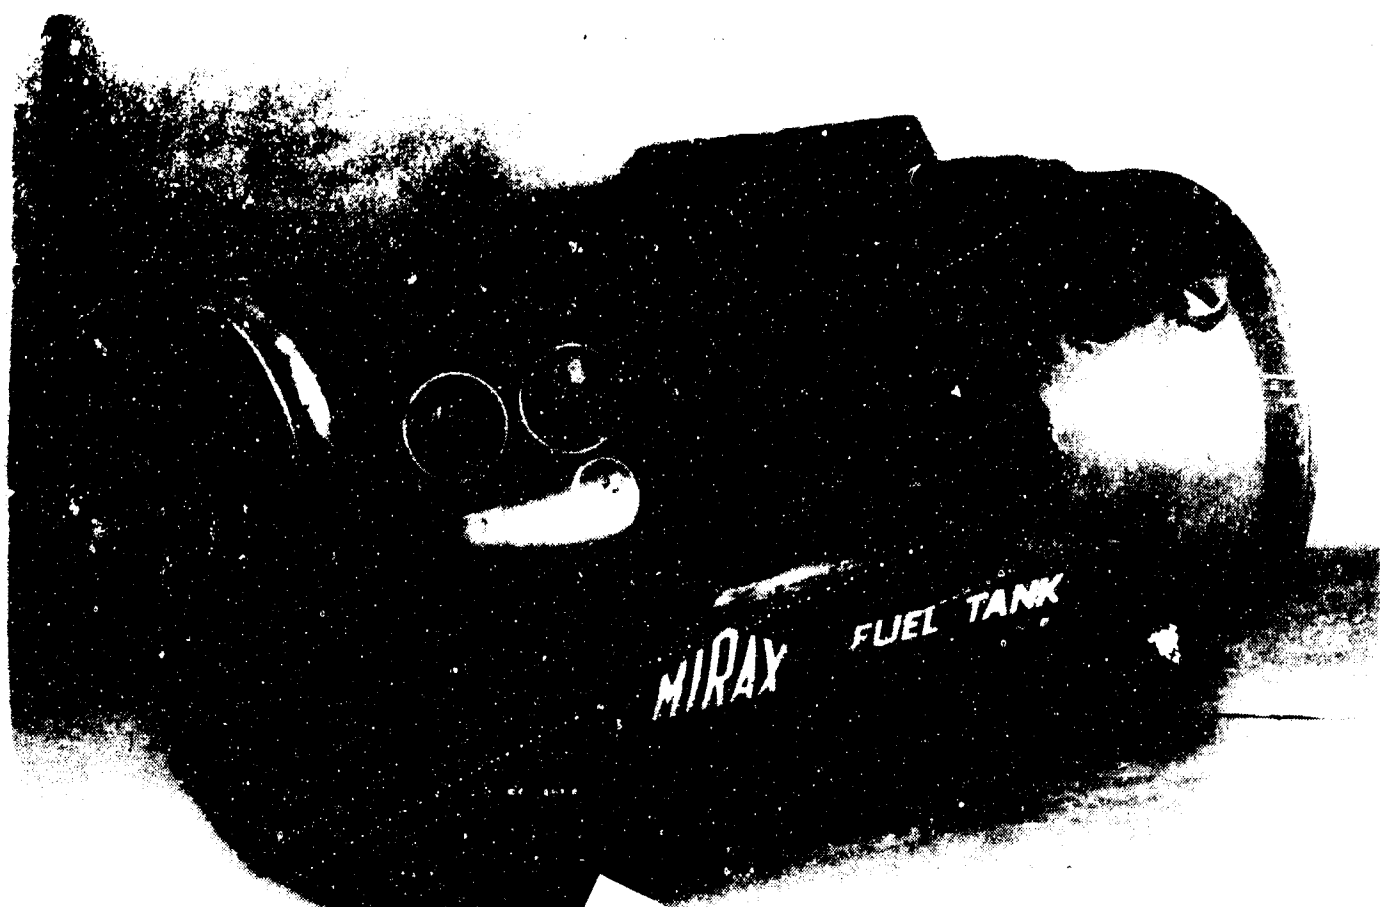
Final Inspection Report
FIG. NO. 39

Upper and lower surfaces of tank show generally good condition of paint and terne coating. Pitting - to a depth of approximately 0.010 inch - was measured near vent fitting. Shell was perforated just below plug fitting shown at left of upper view. Interior photo marked Fig. No. 67 at the end of this report reveals no corrosion on interior surfaces due to protective grease-like coating.

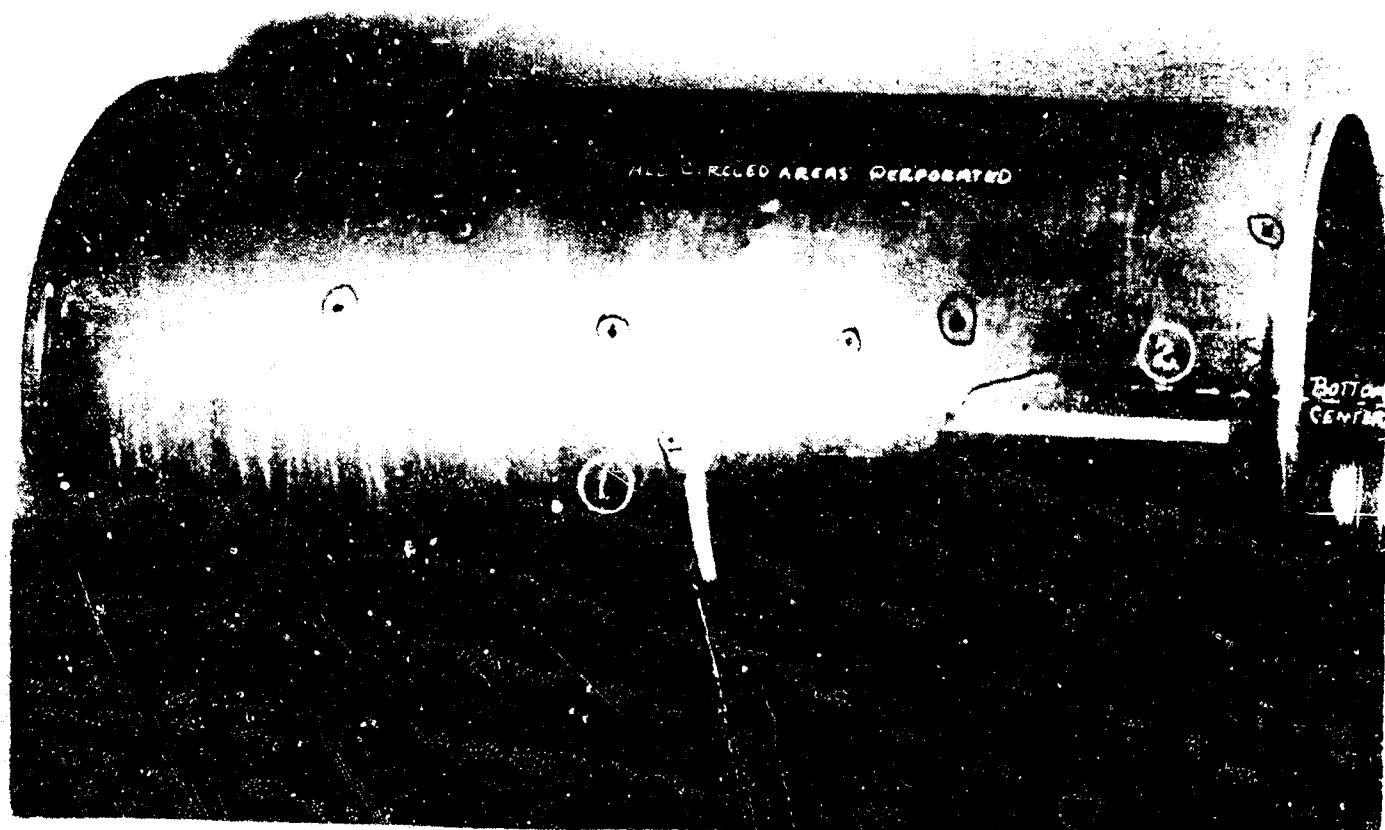
Final Inspection Report
FIG. NO. 45

Upper surface shows destruction of paint and pitting in way of sea water reservoir. Bubbling of paint near fittings is indicative of corrosion build-up underneath. Lower surface shows extent of perforations, originating from interior condensation. See Fig. No. 45 for close-up of perforated areas 1 and 2. Interior photos - Fig. Nos. 64 and 65 at the end of this report show more clearly the extent of corrosion caused by water remaining in the tank.

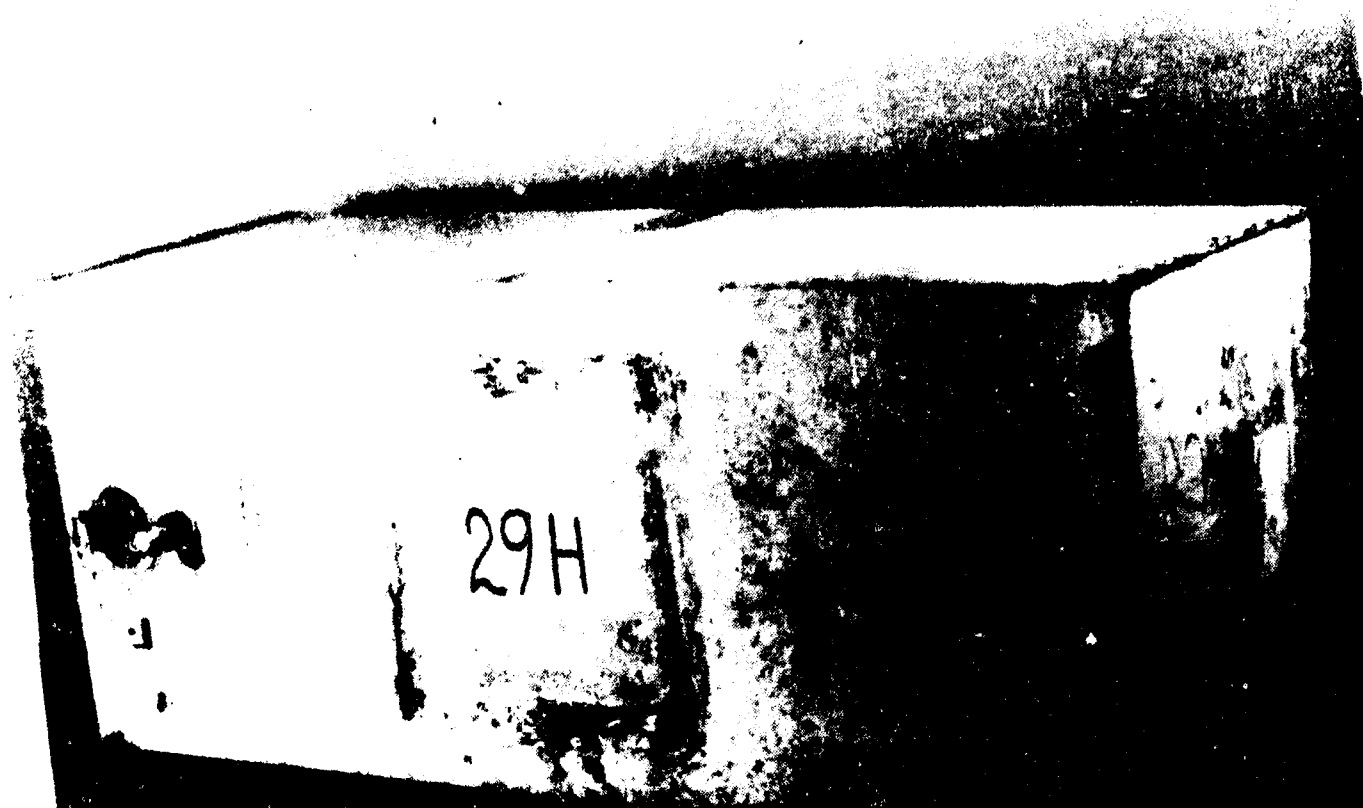
Final Inspection Report
FIG. NO. 54

Upper and lower surfaces of tank show characteristic "chalking" of sacrificial zinc coating. Only negligible corrosion spots were found, except at welded closure flange.

Arrows point to the pitted and perforated cadmium plated fuel level transmitter plate. This is not a part of the listed tank.
